Damage repair after incident 20240306

On March 6 we had an incident with the Sonex PH-AWX. The wheel flipped over during landing. Fortunately no further damage to propeller and engine.

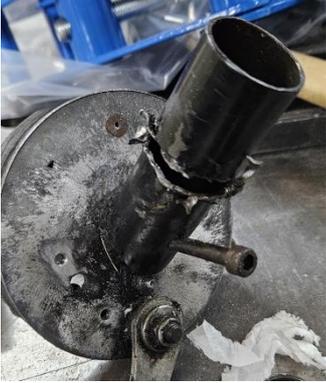
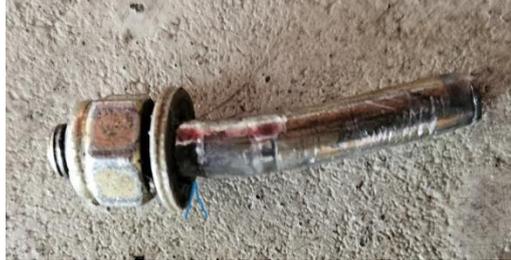
Investigation revealed that a bolt in the left wheel strut was broken and the hole was bulged out due to extreme shimmy.

The right leg was still 'intact' but also showed elongated holes. The bolt was also impacted and was collapsing.

The vibration (wheel shimmy) during landing made the axle assembly rotate around the gear leg resulting in elongated holes and damaged bolts.

After careful consideration, it was decided to thicken the tube and place an extra bolt.

The repair was carried out in accordance with AC-43-13-1B, chapter 4.92 (repair by welded sleeve) and 4.102 (landing gear repair).

The elongated holes were first welded shut and a sleeve was welded over the tube. The original hole in the gear leg was also a bit too large and a bit damaged. So after aligning and assembly an extra hole was machined with a tight fit for the bolt. Placing an extra bolt also will make it fail saver.
